CONCRETE AND ROCK CORE TESTS
MAJOR REHABILITATION OF STARVED
ROCK LOCK AND DAM, ILLINOIS WATERWAY
CHICAGO DISTRICT, PHASE I, REHABILITATION

Richard L. Stowe, Barbara A. Pavlov, Ging S. Wong

September 1978

Prepared for U. S. Army Engineer District, Chicago
Chicago, Ill. 60604

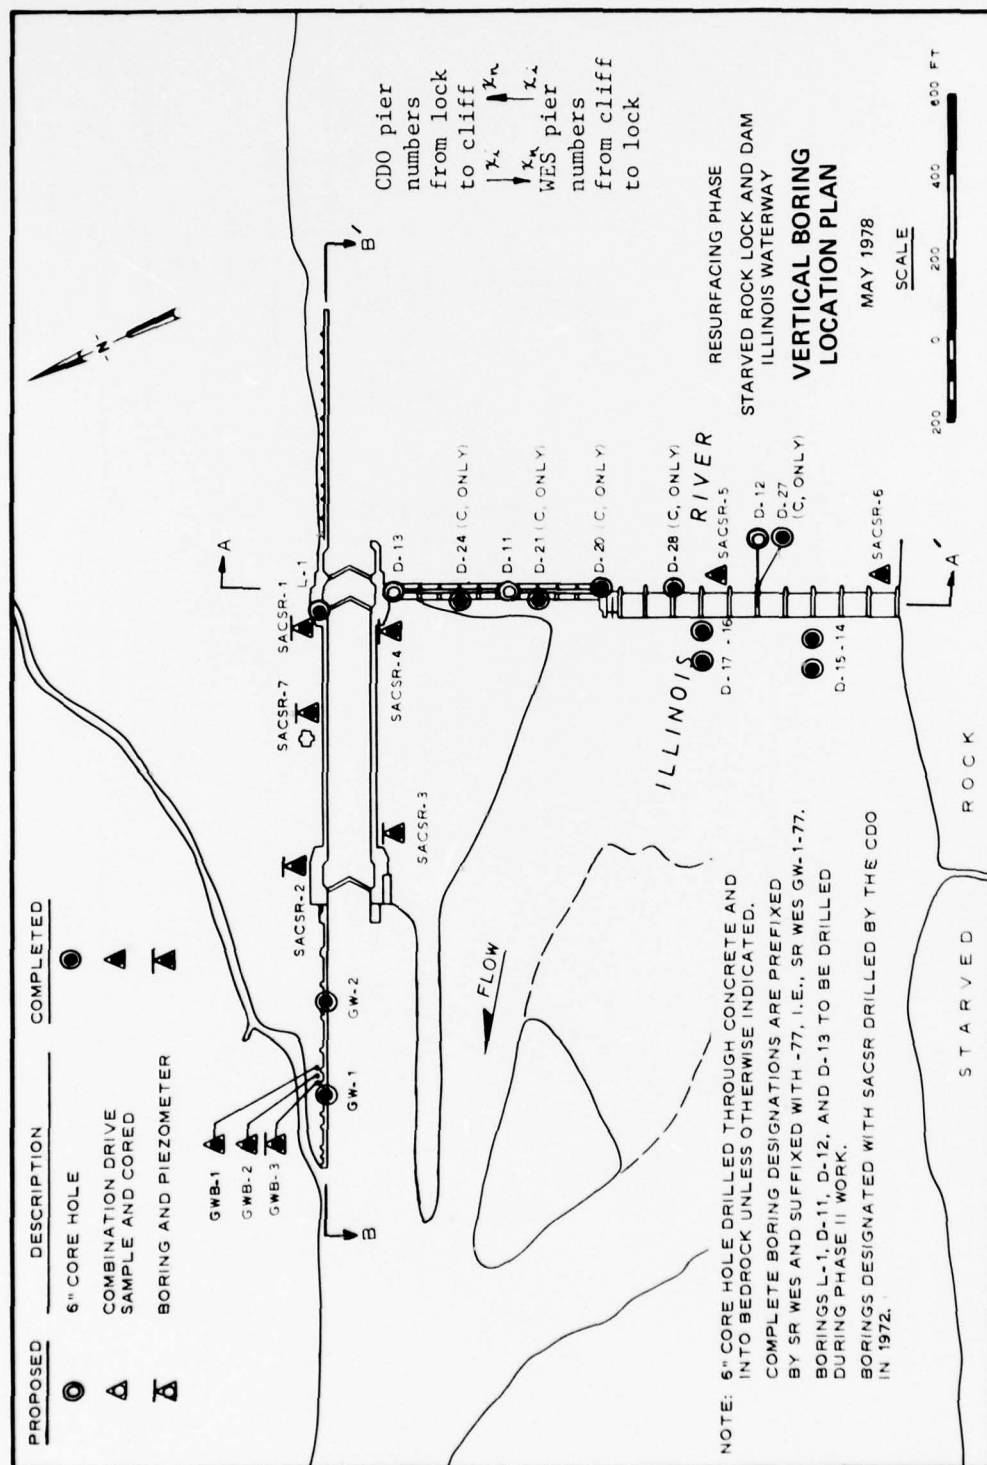
a. Vertical boring location plan

20. Three boreholes were made into backfill material (GWB-1, GWB-2, GWB-3); see Figure 1a for boring locations. Approximately 55 ft of material was recovered. Only one borehole (GWB-1) reached bedrock and penetrated 1 ft. Bedrock overburden was probably spoil from the lock and dam excavations and consists of a mixture of clay, sand, and gravel. The backfill material varies in proportions ranging from 80 percent loose sand on top (clayey sand) to 80 percent compact clay near bottom (sandy clay) with pockets of gravel interspersed with the sand and clay layers. Up to 20 percent gravel is found within the sand and clay layers. Bedrock recovered was a green gray shale layer topping a sandstone reached at el 431. This puts the rock in the Kress Sandstone or at the contact of the Shakopee Dolomite and Kress Sandstone as inferred from comparison of this hole with surrounding lower approach wall boreholes.

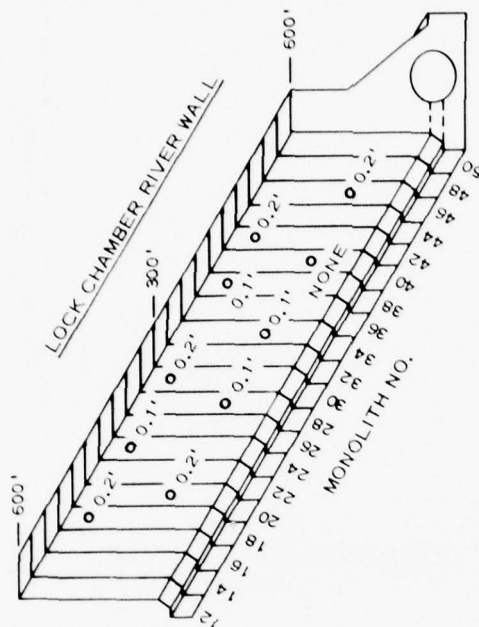
68. Depth of Deterioration. The average depth of concrete deterioration throughout the eroded portion of the wall is 0.2 ft; maximum depth of frost-damaged concrete is 0.3 ft (see Plate 1 for individual depths of frost-damaged concrete at each boring location).

71. Depth of Deterioration. The average depth of deteriorated concrete throughout this side of the wall is 0.2 ft; the maximum depth is 0.2 ft (see Plate 1 for depth of deteriorated concrete for each boring). The deepest frost-damaged concrete is near the top of the wall. All of the core except the one taken from monolith 40 exhibited frost damage near the vertical lock wall surface.

BORING LOCATIONS SHOWING DEPTH
DETERIORATED CONCRETE, LOCK WALLS

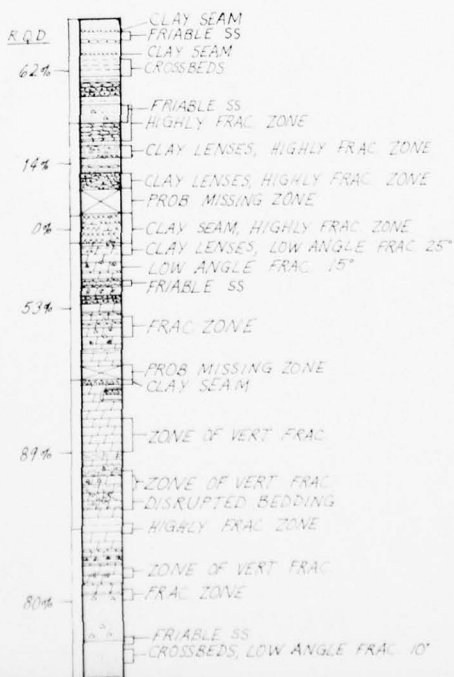
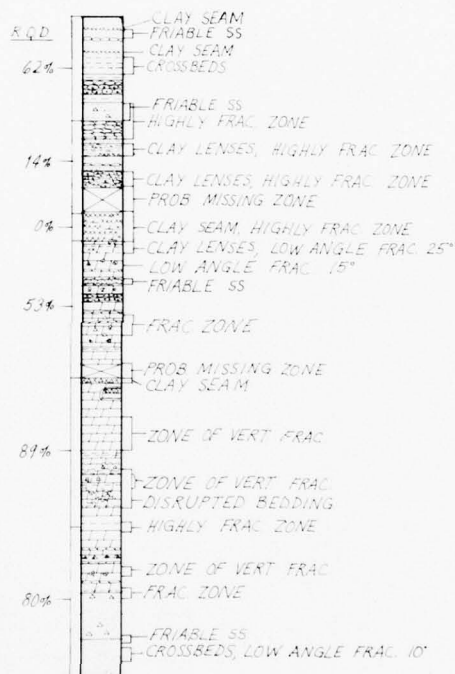
SR WES D-14-77

24. There are a few discontinuous clay seams and pockets in the St. Peter and near the top of the Shakopee. The largest occurrence of clay is a 1-ft section of grey clay found in D-14. The clay was analyzed by X-ray diffraction and consists essentially of kaolinite, illite, and a mixed layer clay containing montmorillonite, which will swell in water.

25. Boring D-14 is located 4 ft downstream from tainter gate pier No. 4. The clay was not found in D-15, which is 15 ft downstream from D-14. Nor was it found in the Phase II boring D-12 which goes through Pier No. 6 located about 140 ft to the northeast of D-14. It is not known if the clay is present under the tainter gate section just upstream

from D-14. It is recommended that one boring be drilled through the sill of tainter gate No. 4 (counting from the bluff side of the dam) during the scour detection program scheduled in FY78. The top of the clay is at el 412.25, the design el of concrete-rock contact is 425.48, and the actual contact of concrete and rock in D-12 is el 416.5. The presence of clay and the concrete-rock contact needs to be verified just upstream from D-14.

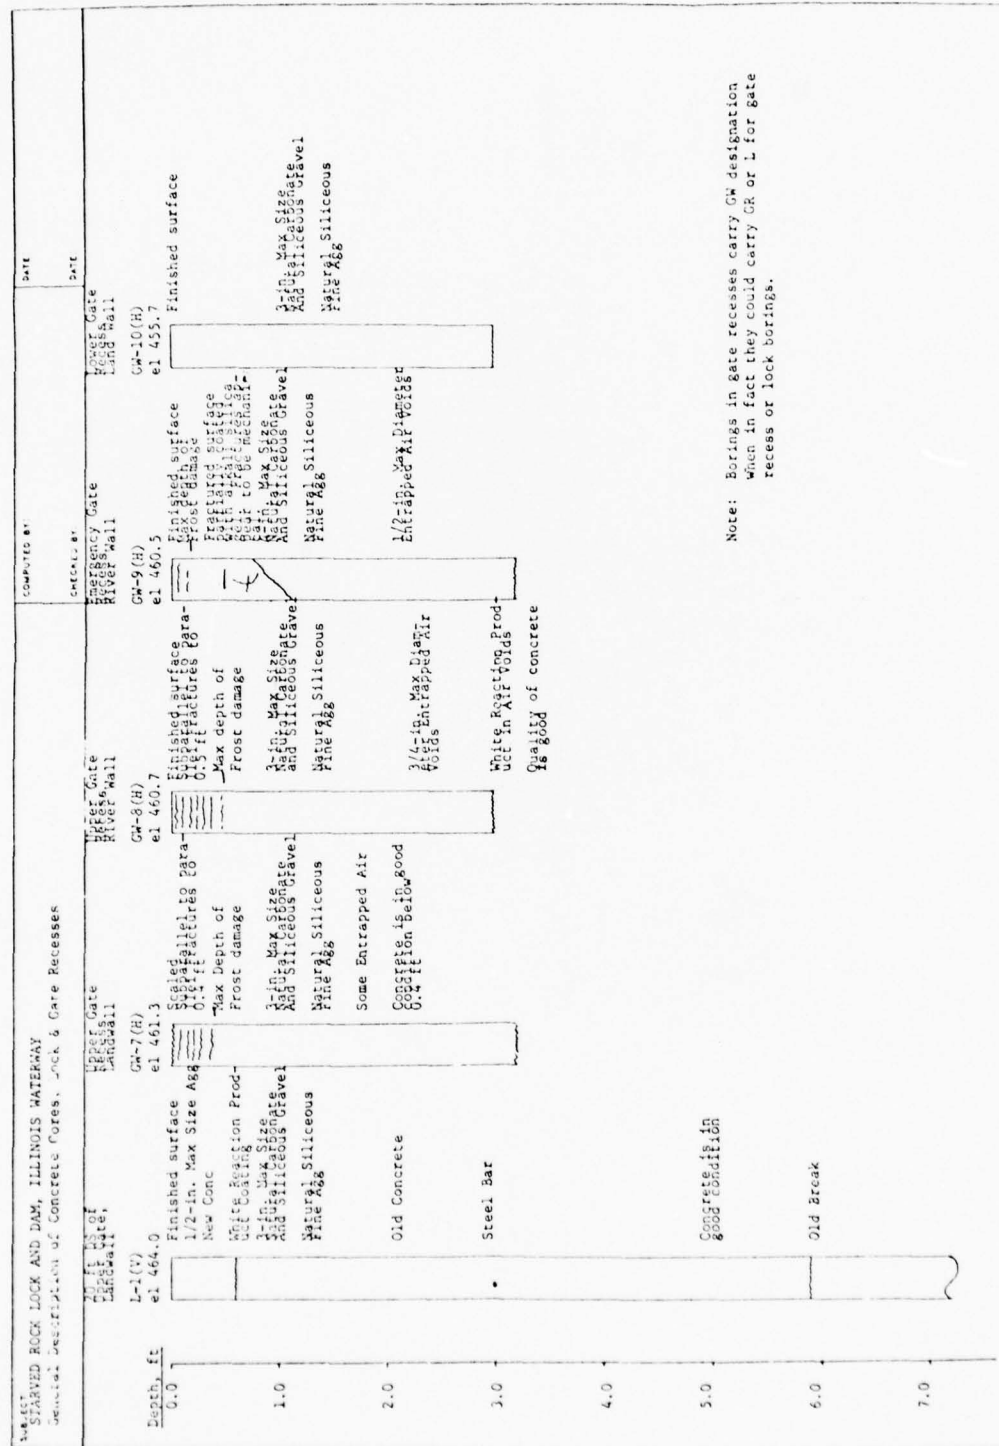
PLATE B2

7. Cores GW-7, -8, and -9 showed the effects of freezing and thawing damage as cracking in the upper parts of the cores (Plate B2). The cores showed subparallel to parallel cracks near the surface to a depth of about 0.5 ft (Plate B2). Photograph B1 shows the near-surface concrete from core GW-9.

Note: Borings in Gate recesses carry GW designation when in fact they could carry GR or L for Gate recess or lock borings.

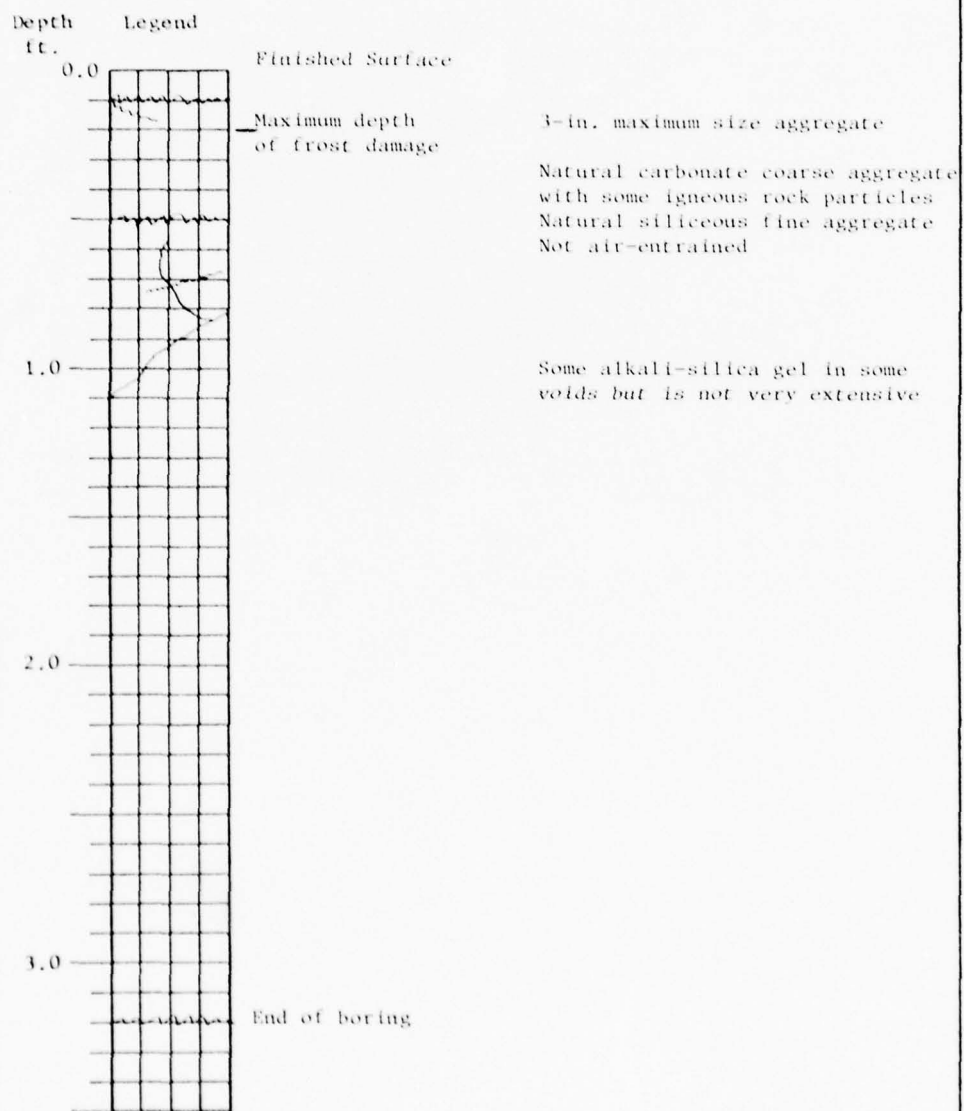
Core SR WES GW-9-77 contained traverse cracks near the top of the core and incipient cracks deeper in the core.

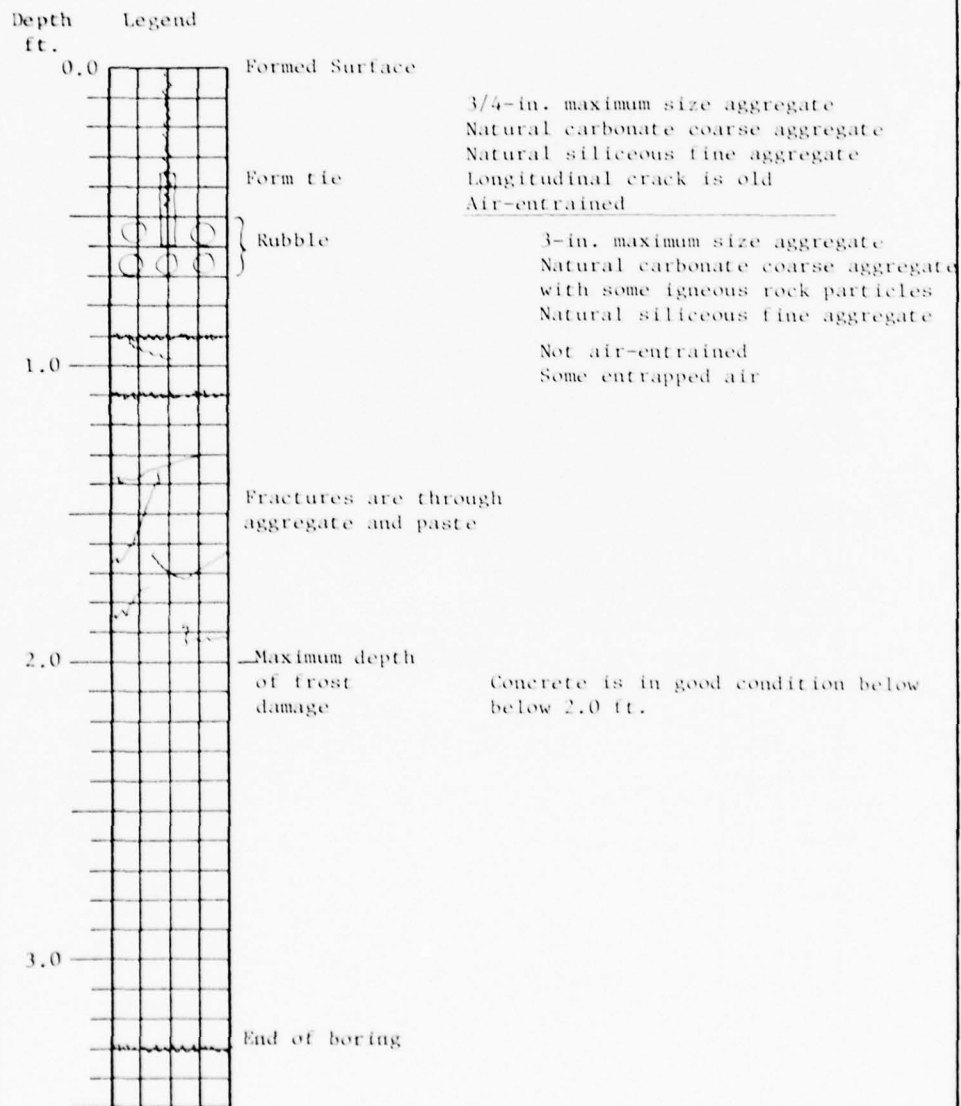
Core SR WES D-1-77 has been resurfaced with a layer of new air-entrained concrete. The zone directly beneath the resurfacing was damaged by frost action and disaggregated during drilling.
